M.V. DELZOUKRE

IMO NO. 9330111

Collision

Date of casualty: 06 March, 2008

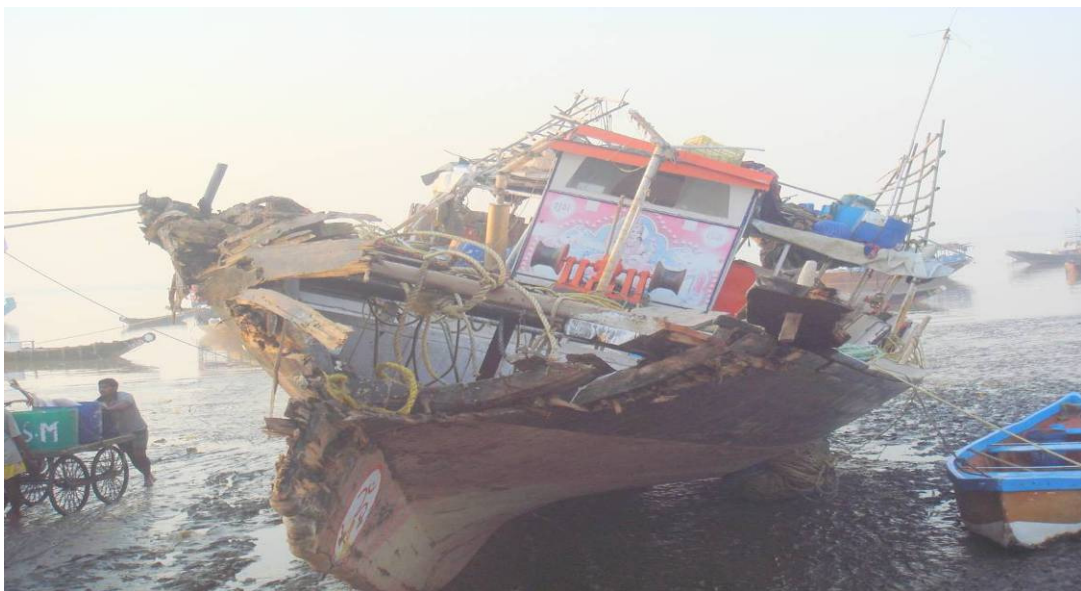
As per the statements of fishing boat crew who did their best in attracting attention of the vessel by whistling and shouting but all in vein. Due to the look out being not maintained on board the vessel, no attention was given and the vessel after collision continued on her course maintaining same speed. Collision caused severe damages to fishing boat and the crew was left stranded at sea.

Image: Damaged Boat
