M.V. LEEDS CASTLE

IMO No. 8010697

Collision

Date of casualty: 7 January, 2008.

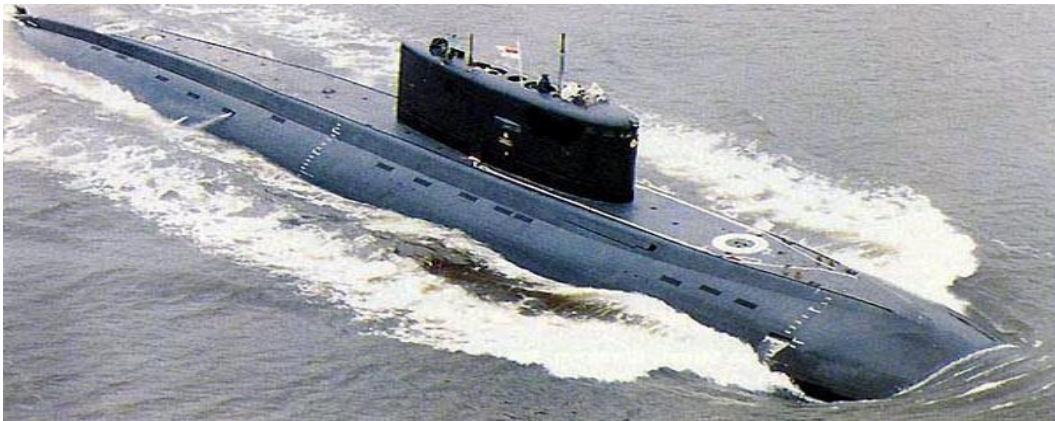
Image: INS SINDHU GHOSH

The railings, mast and antennae of submarine at conning tower level were seen in damaged condition and no apparent damages to hull of MV Leeds Castle were reported.
