M.T. ORIENTAL MARGUERITE

IMO No. 9407201

Collision

Location: Sogal Channel, Kandla port, India

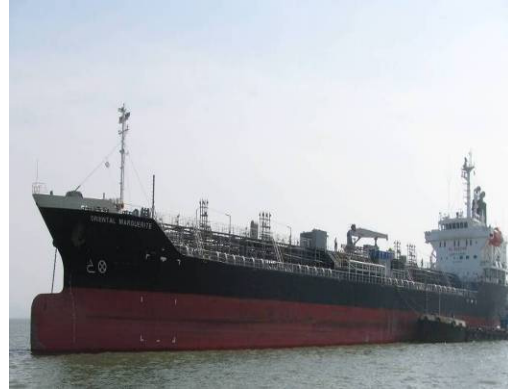
After 2 days at anchor, on 8 October at 0250hrs, as per instructions from port she proceeded in the channel to pick up pilot from outbound vessel at rendezvous. While transiting channel she navigated beyond the assigned Pilot Boarding Ground and collided with outbound dredger. At this moment pilot also boarded the vessel. The fore end of vessel made contact with port side shell plate of dredger causing rupture of forepeak tank and water ingress.

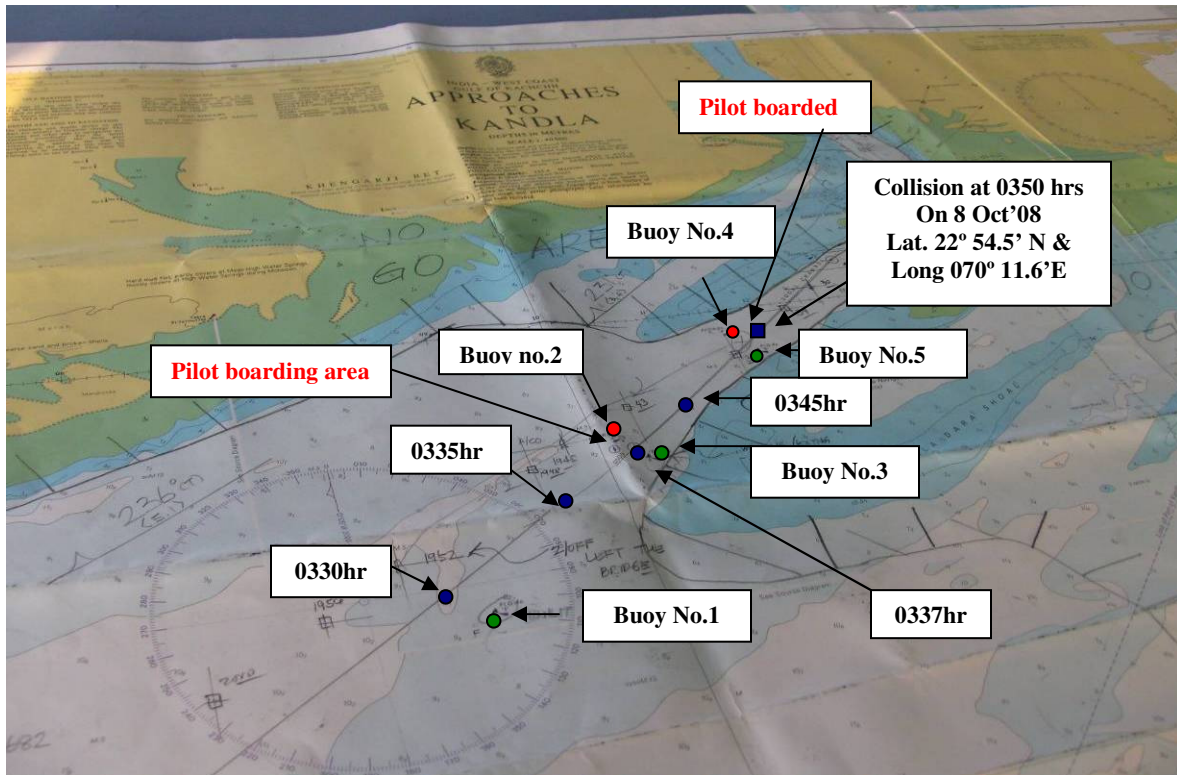
BA Chart 3466

Vessel navigated beyond assigned PBG without pilot up to no.4 buoy
