M.V. SURFING JAD

IMO No. 7374577

Collision

Date of casualty: 22 August, 2008

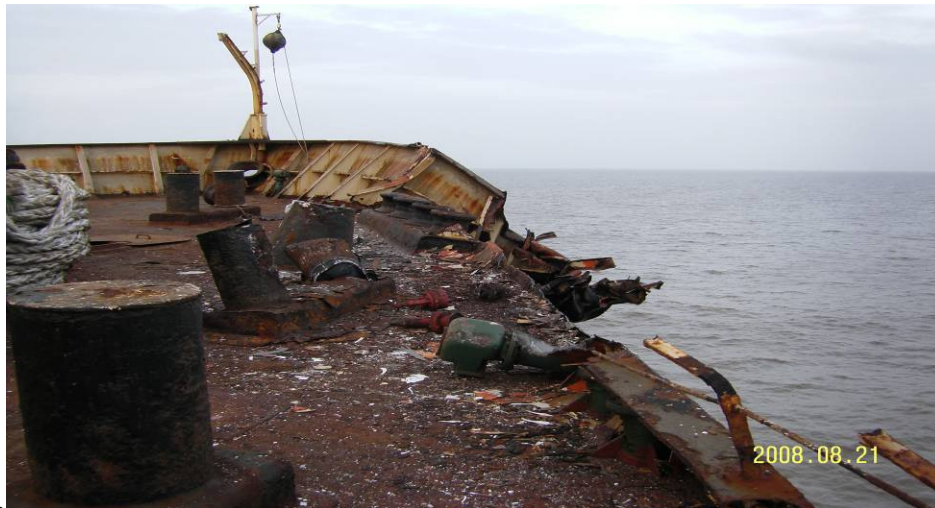
After about 25 minutes of tracking, MV Yossa Bhum collided with the bulk carrier at anchorage making contact of her port side bridge wing to starboard side forecastle deck of vessel at anchorage. The vessel at anchor also lost her starboard anchor with 4 shackles length of anchor chain. After having lost her anchor she started drifting with flood tide but later re-anchored safely.

MV Surfing Jad – Damaged Forecastle deck

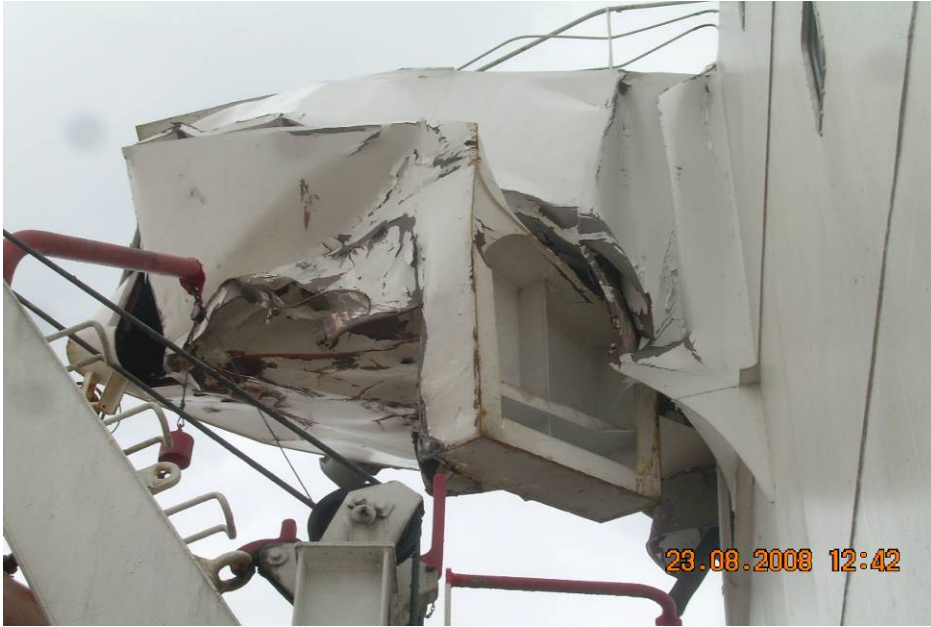
MV Yossa Bhum- Damaged portside Bridge wing
