**MV GLOBAL PURITY,
IMO NO: 9550149
COLLISION WITH INDIAN COAST GUARD VESSEL
BERTH NO.10, INDIRA DOCK, MUMBAI PORT
23 MARCH 2010, 1621 LT**

SUMMARY

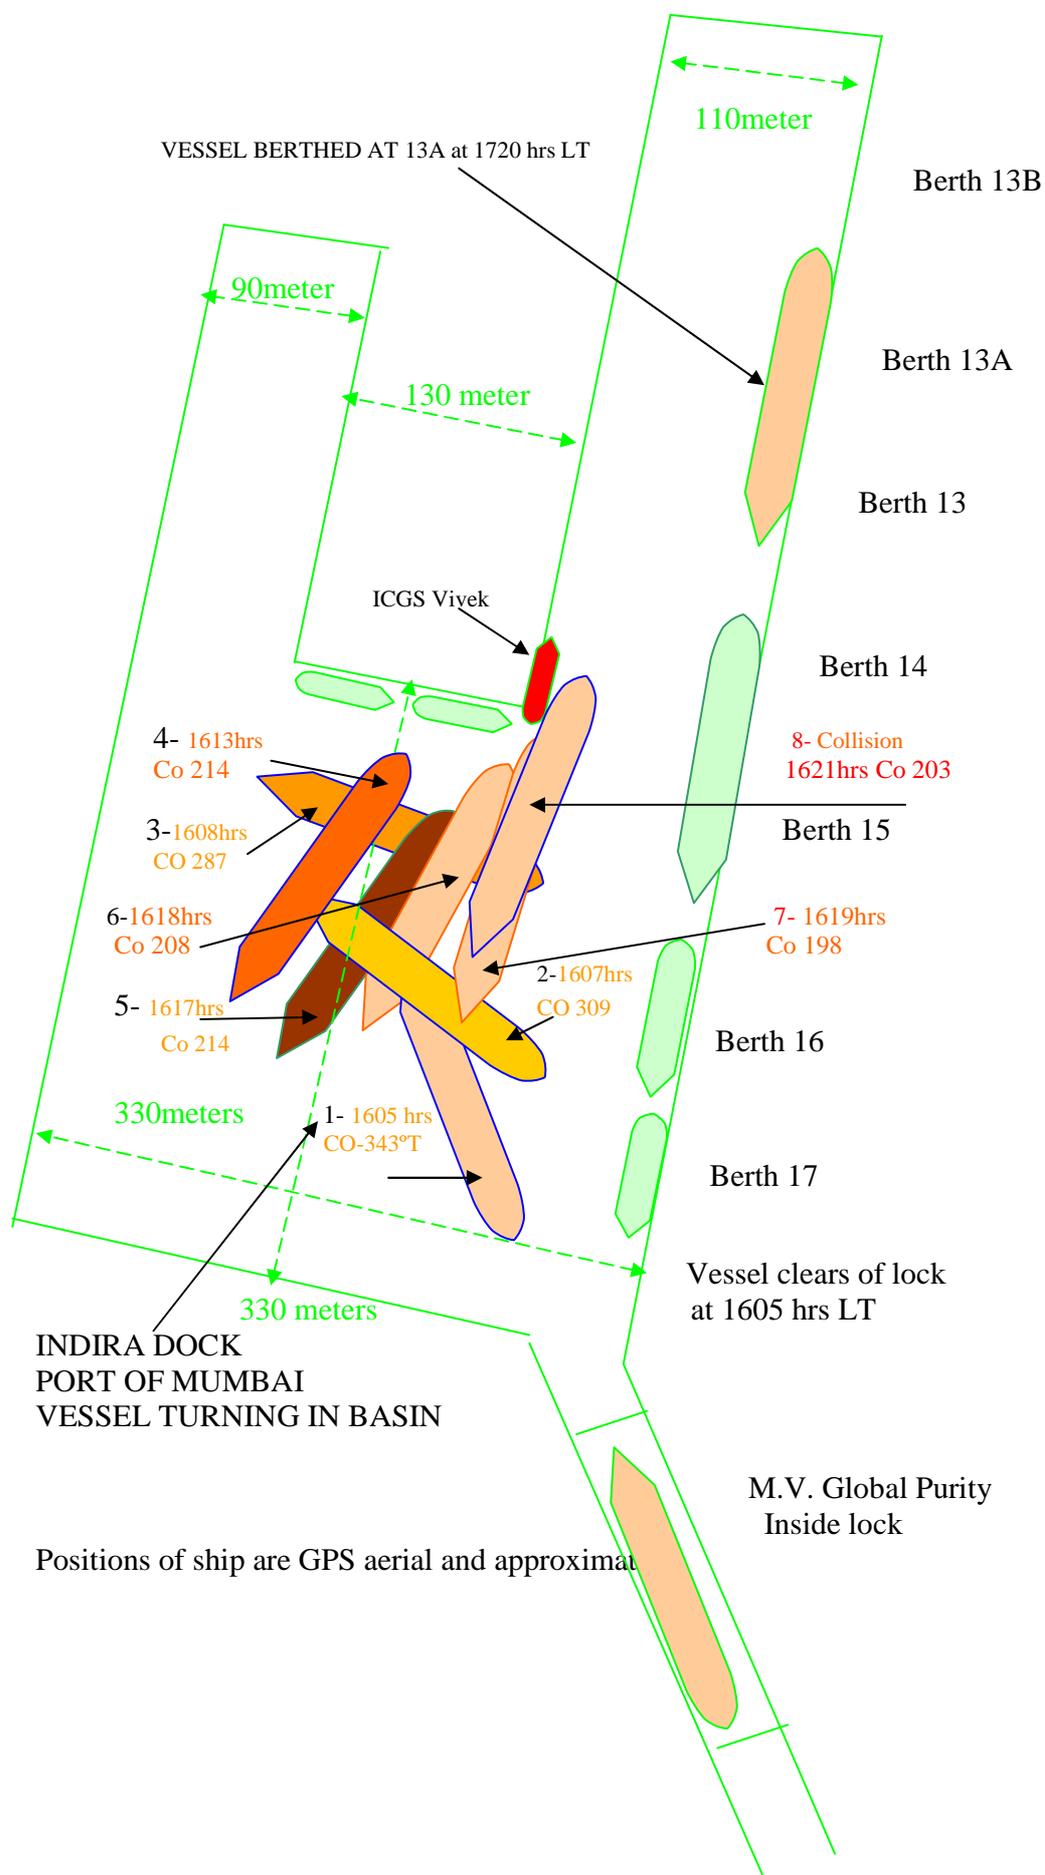
SKETCH A: Indira dock basin – Positions and headings of M.V. Global Purity and timings are LT (Local time). Scale: 1cm = 36.66meter

- It is observed that all was well and under control till 1617 LT, 4 minutes before collision. The vessel was almost in the centre of the turning basin, the minimum clearance at stern being about 66 meters. The vessel had almost completed the turn and she was steady on a course of 214°T with sternway of 0.06 knots i.e.1.85 meters per minute, almost stationary.

- Stern speed continued increasing after 1617hrs. The sternway was 60meters per minute at 1619LT and 28meters per minute at 1621hrs, the time of collision.

- From 1617hrs 1621hrs there was inapt maneuvering when the astern speed of the vessel progressively increased and aft clearances reduced. The vessel was not aligned properly in the turning basin before starting to move astern in narrow passage.

- There was a space of at least 70 meters available between berth10 and berth 15 for the vessel to transit which was sufficient to pass, provided that appropriate maneuvers were made.

- The course at the time of collision was 203° T whereas she should have been steering 193° T to remain parallel to jetties in center of narrow passage.
