M.V. SIAM BRIDGE

IMO NO. 9140061

Collision

Date of casualty: 22 June 2009

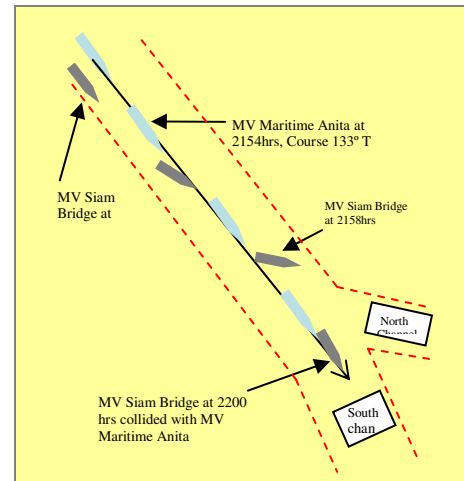
This alteration of course resulted in close quarter situation and at 2200 hrs M.V Siam Bridge made contact of her starboard quarter to port bow of M.V. Maritime Anita.

Engine room of MV Siam Bridge flooded and the section of bow, bulbous bow and fore peak tank of MV Maritime Anita was damaged. Later MV Siam Bridge was towed to dockyard for repairs.
