MV VANCOUVER VICTORY

IMO NO: 8010843

Collision

Date of casualty: 02 April 2009

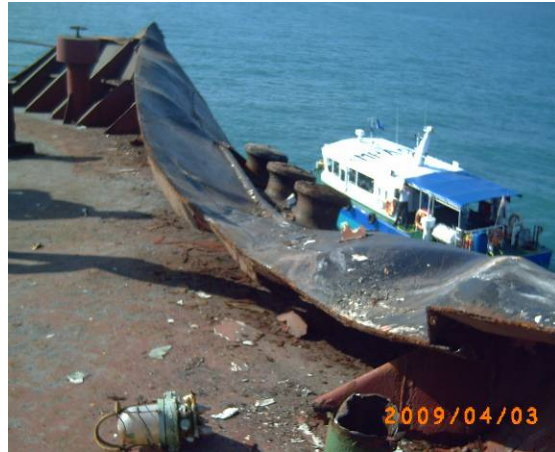
By the time Master reached the Bridge, the approaching vessel had already collided. The starboard side gang way area of other vessel had collided with port side fore castle.

- There was no dedicated look out on Bridge as watch keeper AB was engaged in receiving stores and OOW was attending to various activities including anchor watch keeping. The OOW was not alert and attentive while keeping anchor watch and saw the approaching vessel only at eleventh hour when she was too close.
- The efficiency of OOW was affected due to distraction caused by multitasking.
- The OOW ignored various Bridge procedures which were required of a competent watch keeper.

- **Risk assessment** was not carried out while creating a critical situation due to non availability both Radars.
- **The effect of tide** on the other vessel and subsequent set and drift towards own vessel was not foreseen and taken into consideration.
- **COLREG Violation: The vessel violated COLREG Rule 5 & 7.**

- **Set and Drift not assessed and allowed for:** The vessel was navigating the area during peak of flood tide. The peak of flood tide was at 2300hrs with a rate of 1.6-1.7 knots setting to a direction of 235° T, almost south westerly and the vessel which was heading south east was more or less broad on to tidal current and thus being bodily drifted in a south westerly direction towards MV Vancouver Victory and was left unmonitored, unnoticed, unattended for some time till it resulted in this collision.
